## 1. Groff's Mill Park Streambank Restoration - Montgomery County, Pennsylvania

John W. Munro  
Munro Ecological Services, Inc.  
990 Old Sumneytown Pike  
Harleysville, PA 19438

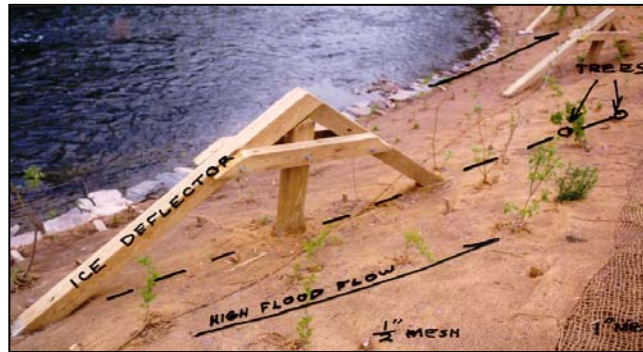
**The photo-diagram of an ice deflector taken during installation shows the orientation of the deflector to current direction and the location of protected tree plantings.**

Well, the six deflectors took a beating. Within two years only one remained. That remaining one still protects a 15-foot swamp white oak, nine years after installation. What went wrong with the others? The deflector size, material and design were apparently sufficient to withstand the pounding, but:

- If the deflectors were not lined up exactly parallel to the high-water current direction they would be toppled sideways (and some were).
- The direction of current flow changed during high water, and was not predicted well in the area where the floodwaters left the channel and spread onto the floodplain.
- Turbulence, created in part by sticks, leaves and branches caught on the deflector, caused the deflector to vibrate, which gradually fluidized the soil around the footing and allowed the deflector to be pushed right out of its holes, concrete and all.
- Volunteers installing the deflectors paid less attention to the specified details than appropriate and could not be supervised sufficiently, which resulted in oversized excavation, insufficient concrete detailing and inadequate soil compaction. This produced inconsistent deflector installation.

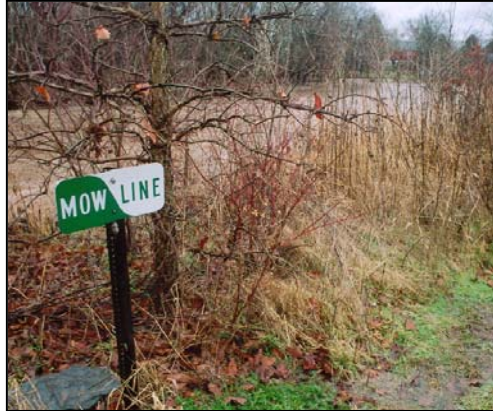
At the end of summer, the Township's annual mowing of meadows is typically done. The mower operator knew about the project and the new plantings but decided on his own that he should just mow the area as he always had. Within a week of this mowing, the new "tall grass" meadow and shrub patches had been

**The installation of no-mow signs followed an embarrassing mowing of original native grasses and shrubs. No mowing in the restored area has occurred since the signs were installed.**

reduced to a height of two inches. Luckily this mistake became a golden opportunity for the project. The Township officials were embarrassed at what their own staff had done and readily agreed to pay for new plant stock. More importantly, "NO-MOW" signs were purchased and placed within the park. In addition, the mowing policy for tall-grass and wildflower meadow areas of several other parks was clarified, and mowing crews were sternly advised to stop mowing at the established lines.

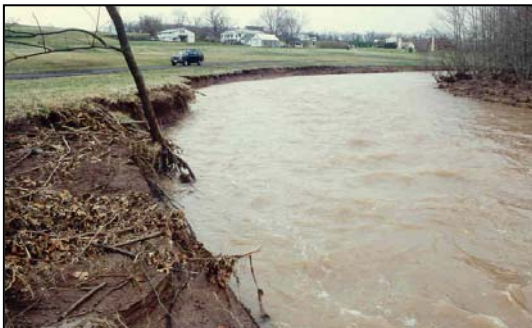
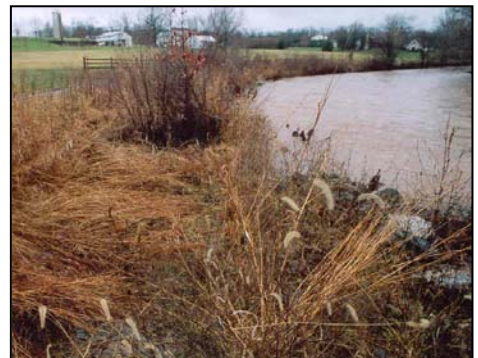
**Before (left) and after construction (right)**
