Legacy Sediment

**What is it, Where is it,
How did it Get There, and
Why does it Matter?**

**Dr. Dorothy Merritts, Franklin and Marshall College
Dr. Robert Walter, Franklin and Marshall College**

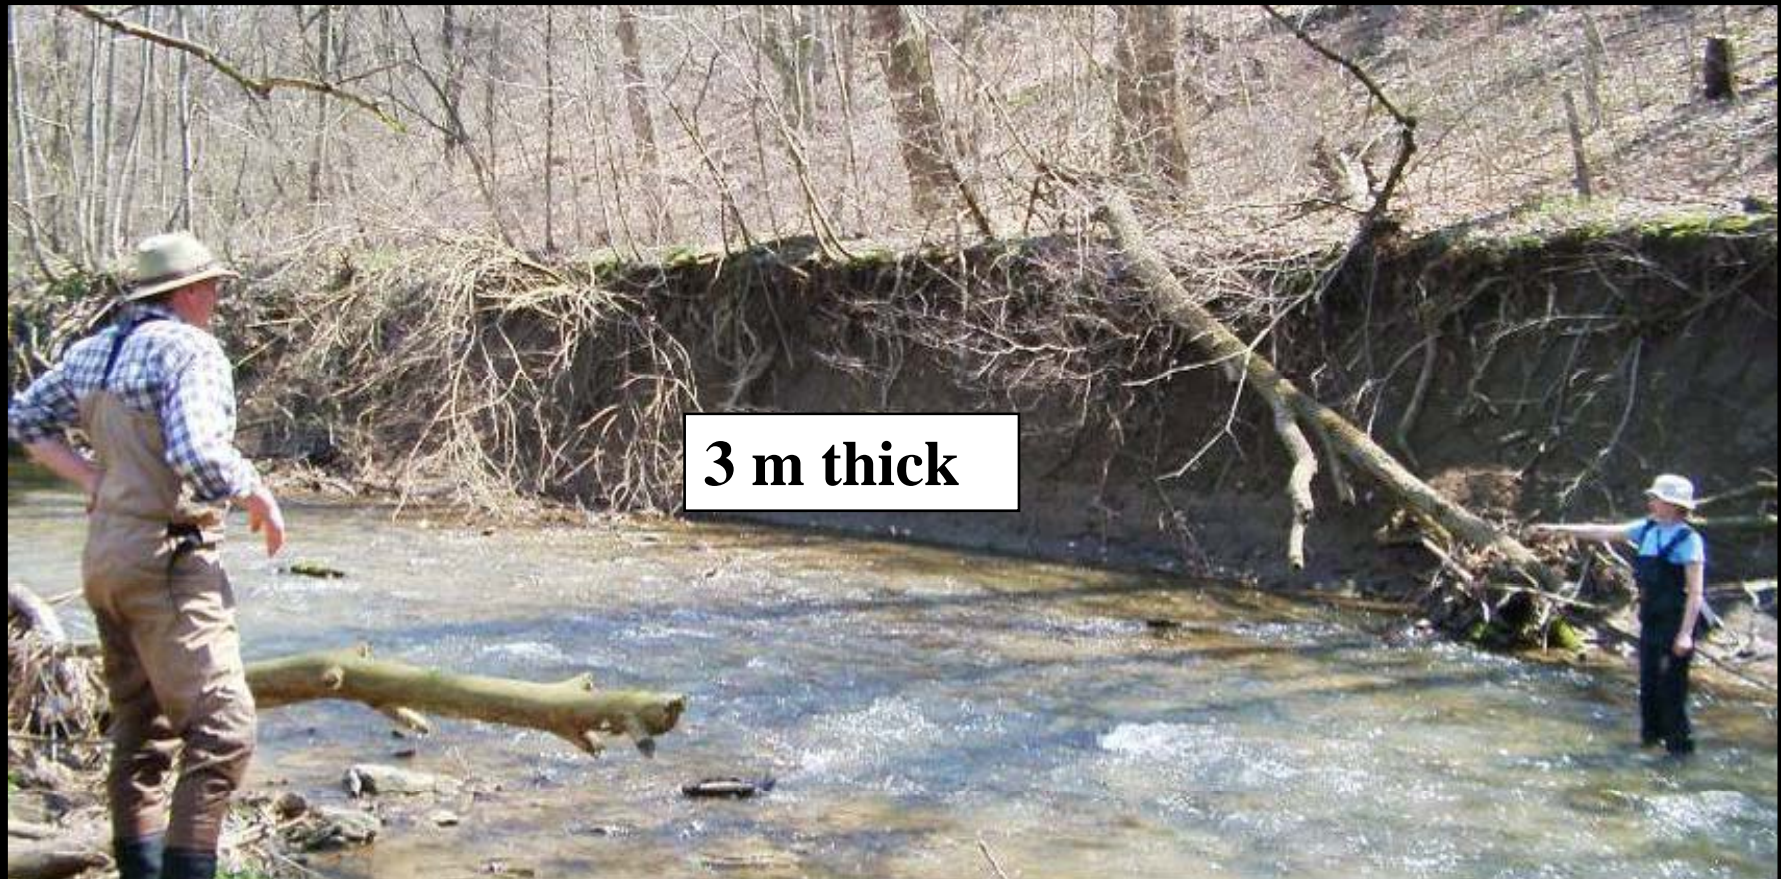
Mill Pond Reservoir Sediment Wedge Upstream of Dam

Denlinger's Mill, W. Br. Little Conestoga, PA

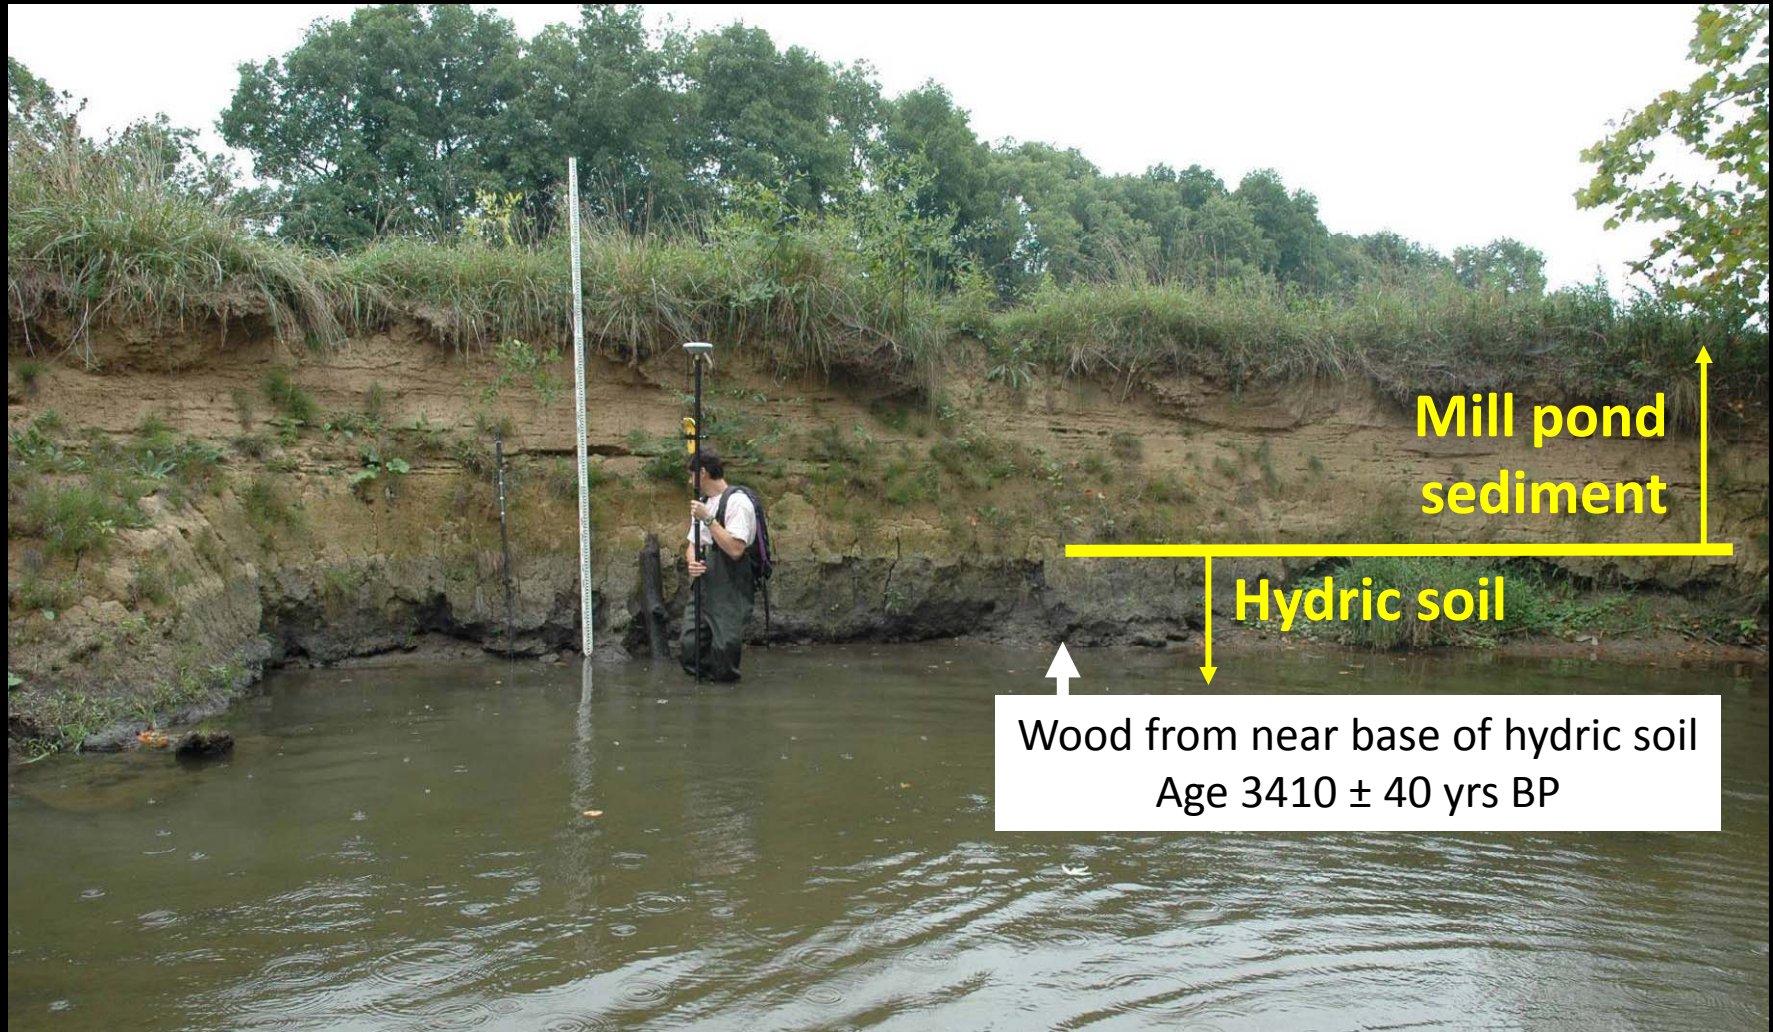
Legacy Sediment Buries Stable, Resilient Wetlands

Pond deposits draped on former organic-rich valley bottom (wetland, hydric soil)

Western Run, Maryland

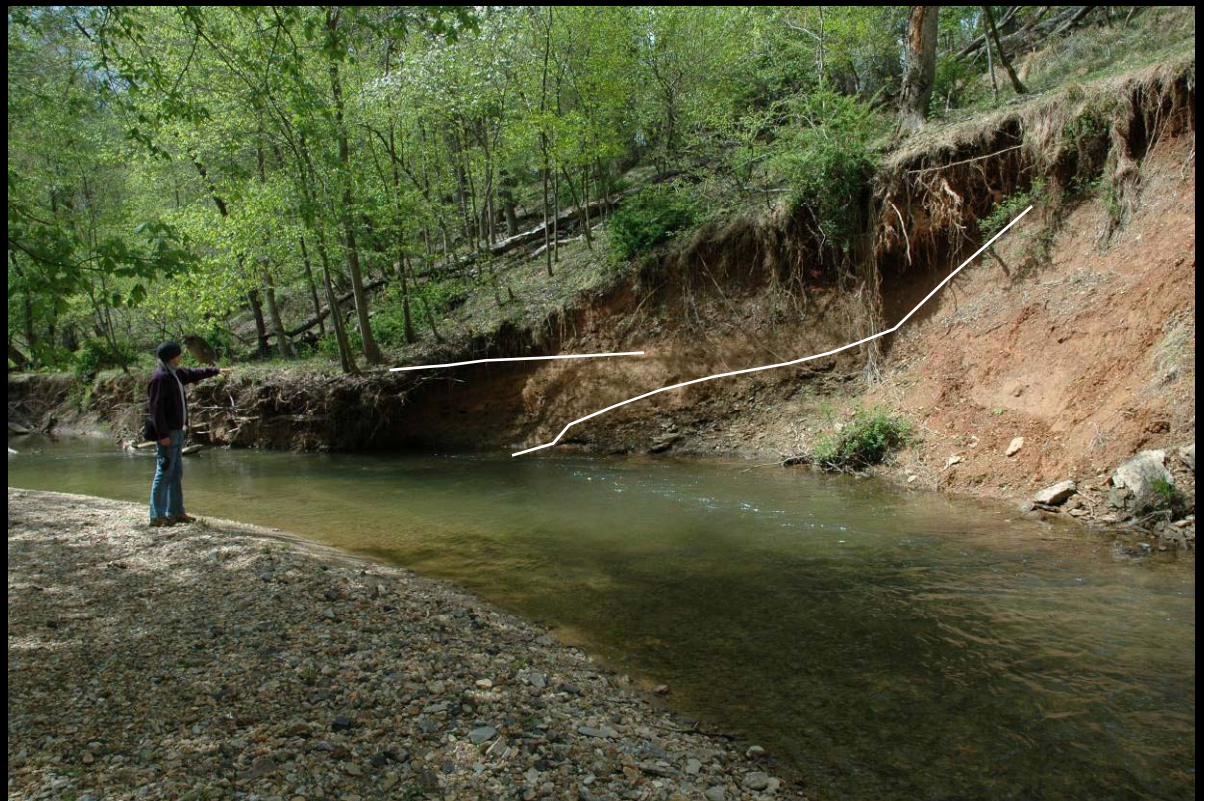
**Historic reservoir
sediment burying
pre-Colonial marsh,
Watkins Mill,
Seneca Creek, MD**

**Historic reservoir
sediment onlap with
Pleistocene (?) colluvium,
overlain by
recent colluvium**

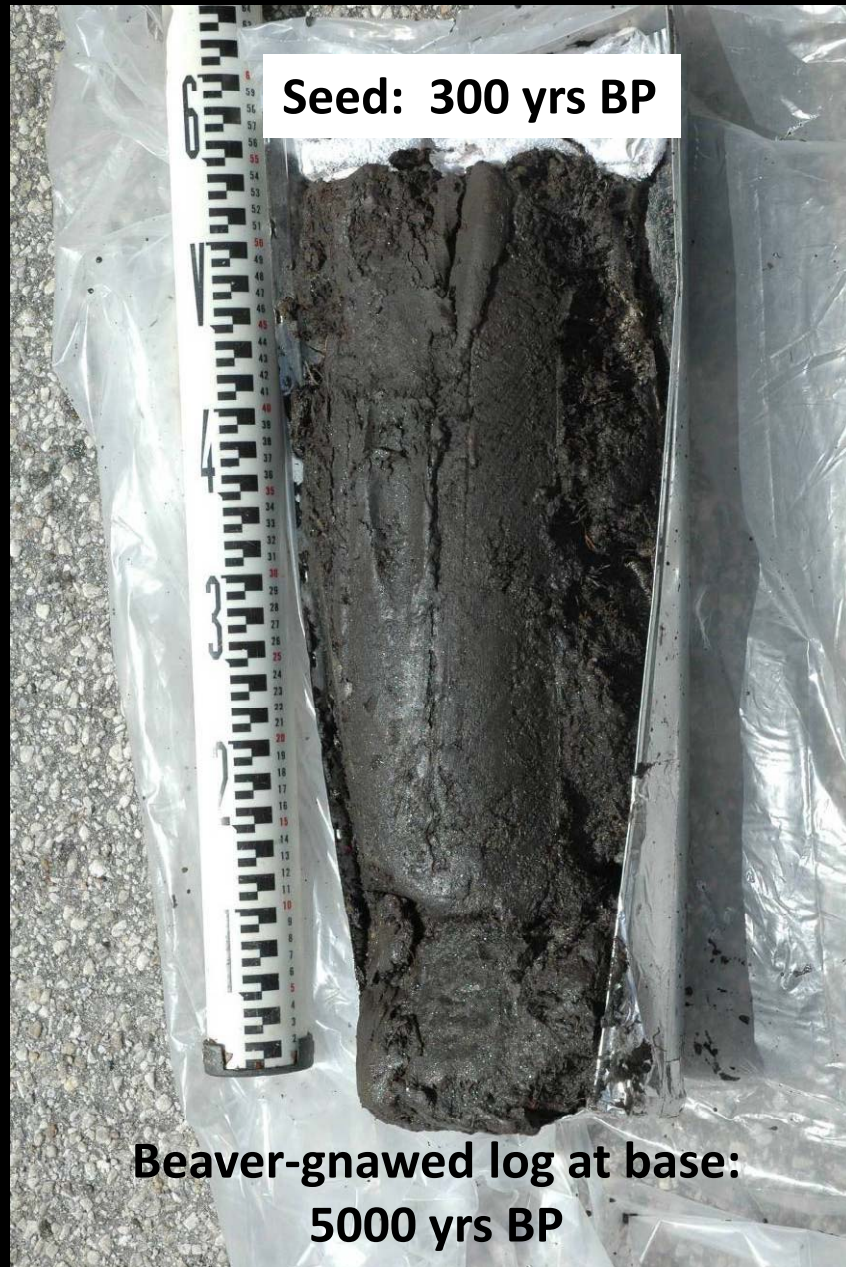
Holocene peat core, wetland seeds

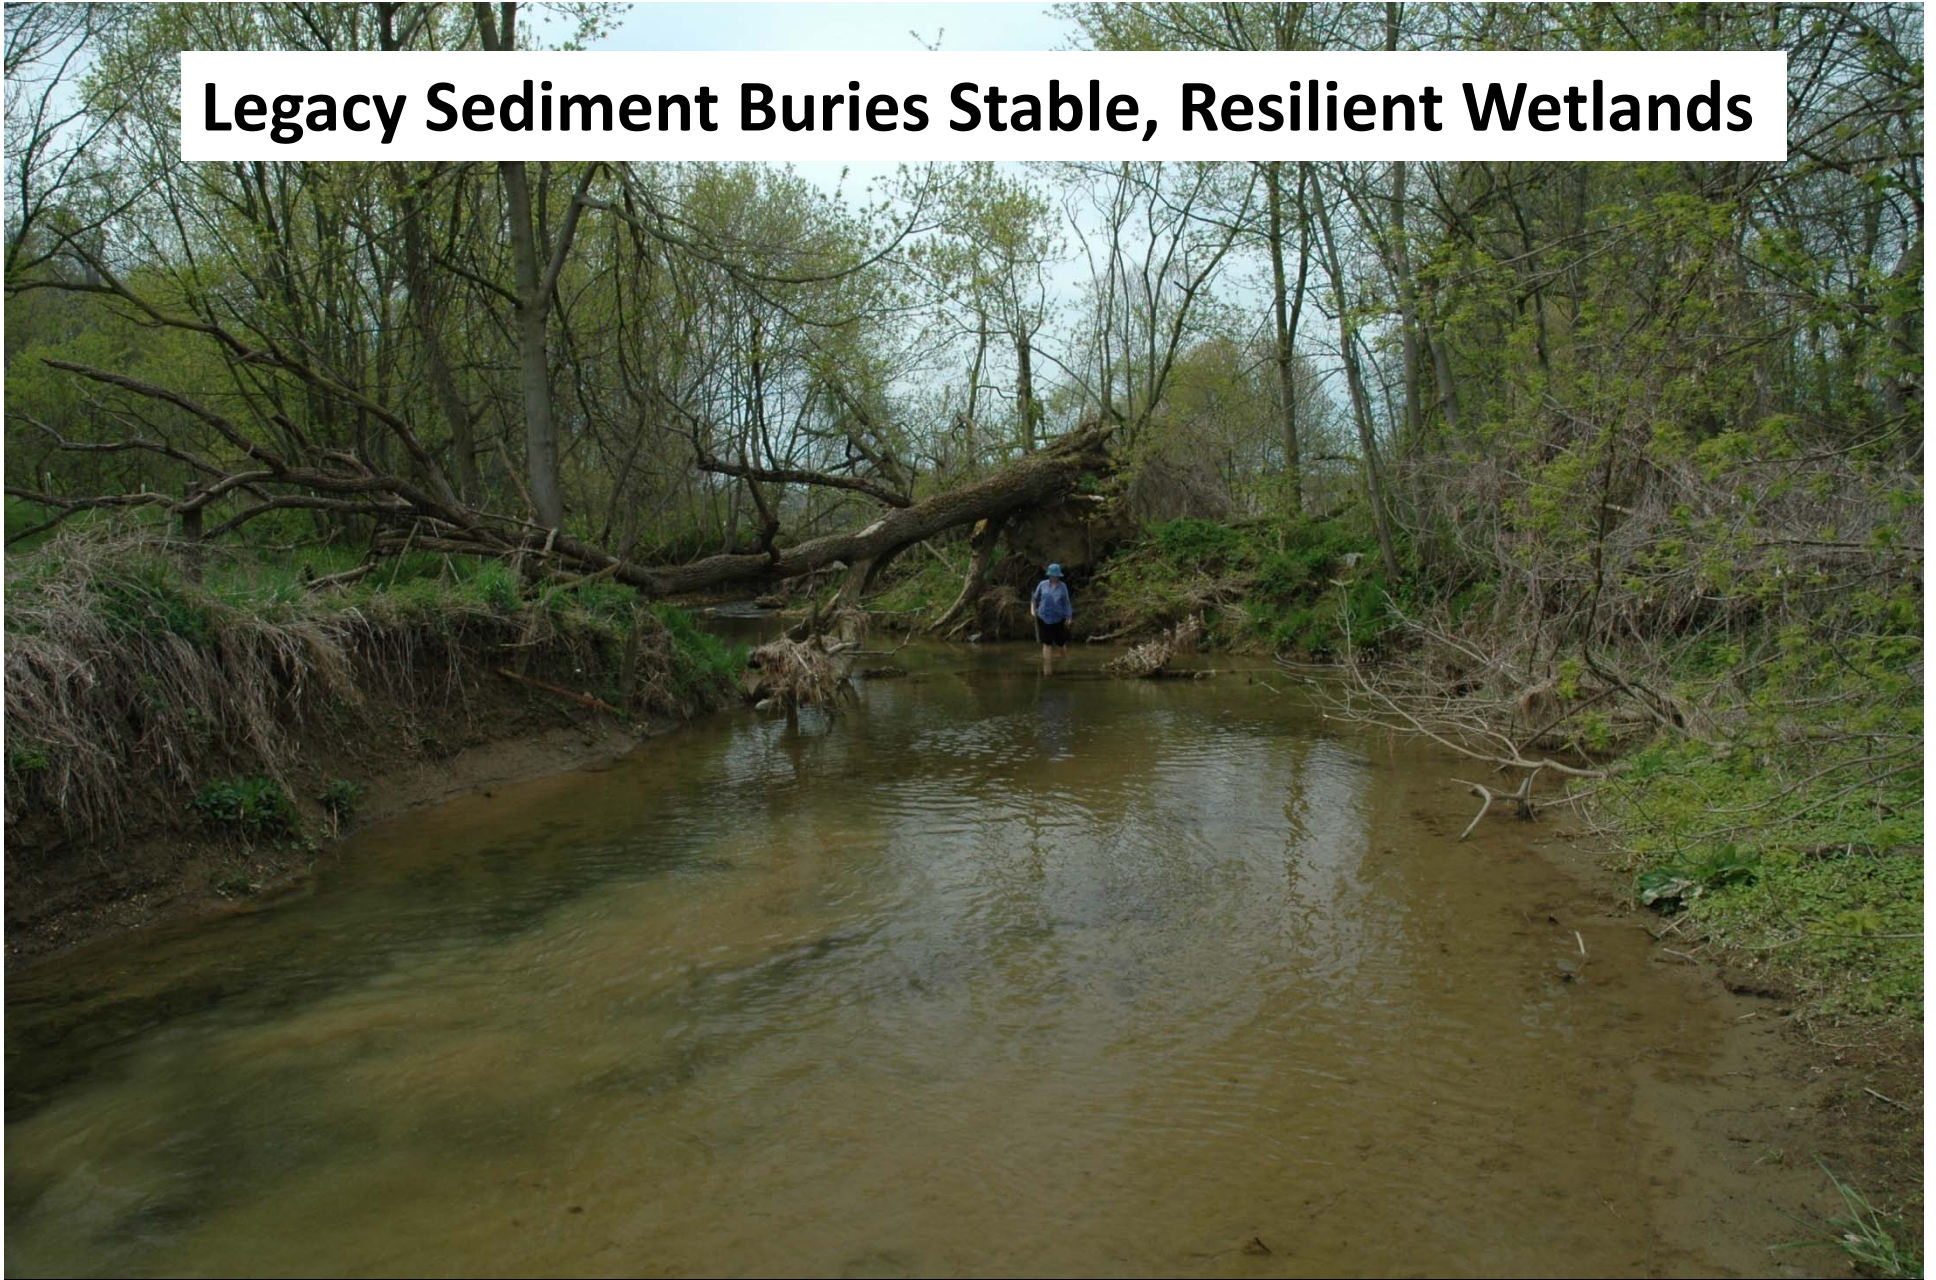
Legacy Sediment Buries Stable, Resilient Wetlands

**Incision after dam removal exposes
buried pre-settlement wetland, 2009**

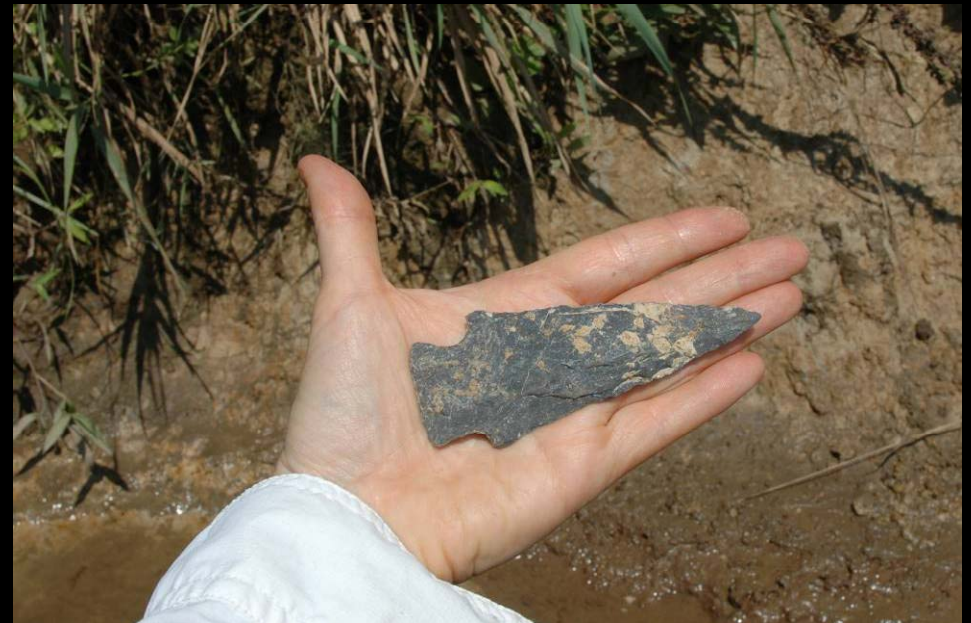
Susquehanna broadspear beneath
mill pond sediment

~4000 yrs old

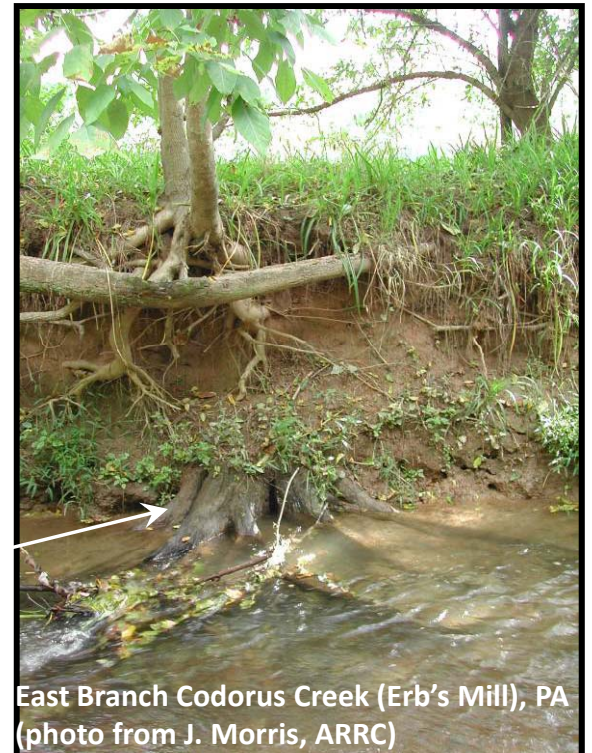
From Wolman and Leopold, 1957,
On the Origin of Floodplains
F

Streams in various stages of post-dam breach conditions

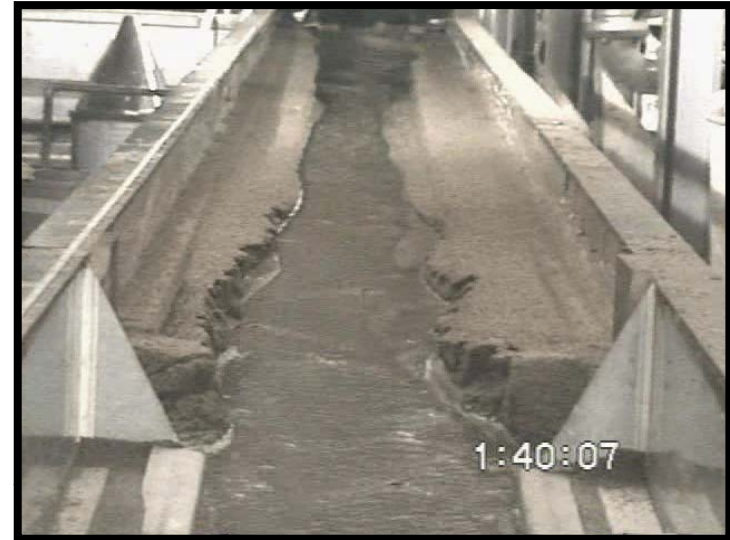
Base-Level Rise and Fall: Dam Building and Dam Breaching

Flume experiments Dr. Allesandro Cantelli,
Univ of Minnesota

1. Graded stream profile

2. Base level rise / Dam building

3. Reservoir filling

4. Base level fall / Dam breaching

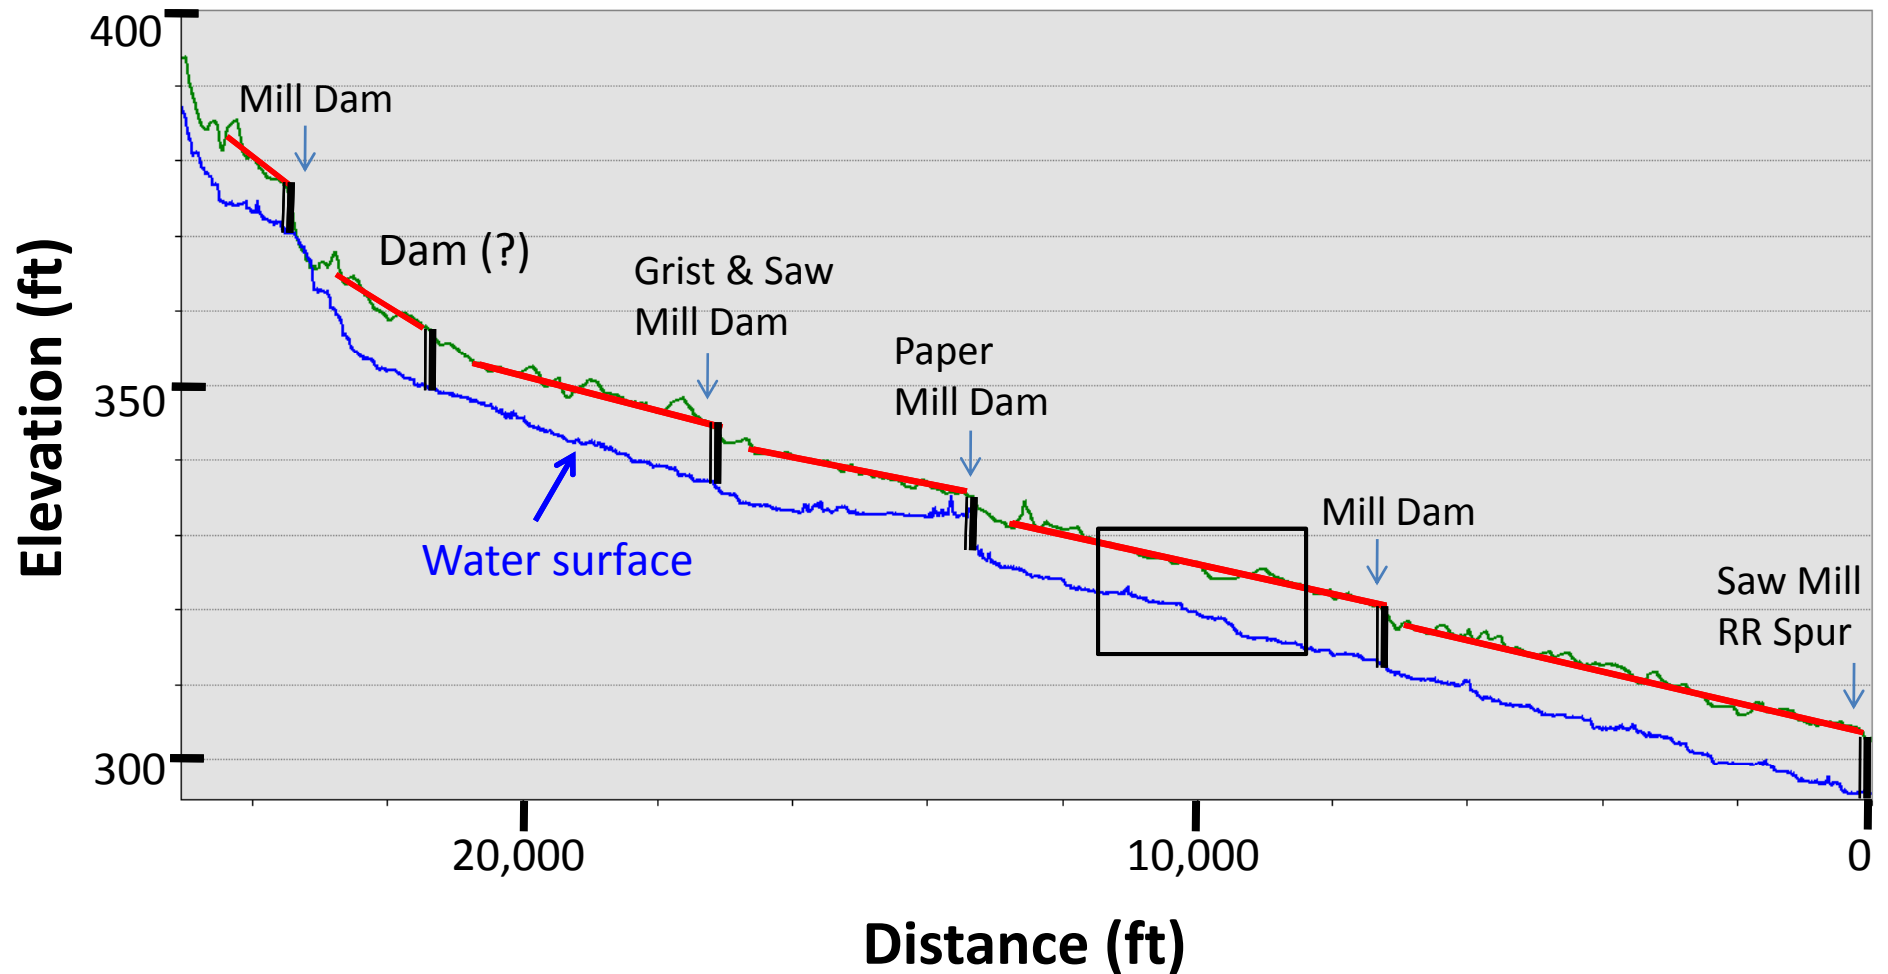
Historic Mill Dams and Reservoir Fill Surfaces, Little Falls, MD

Can trace pond surfaces (fill terraces) to crests of dams

Long profiles from LiDAR

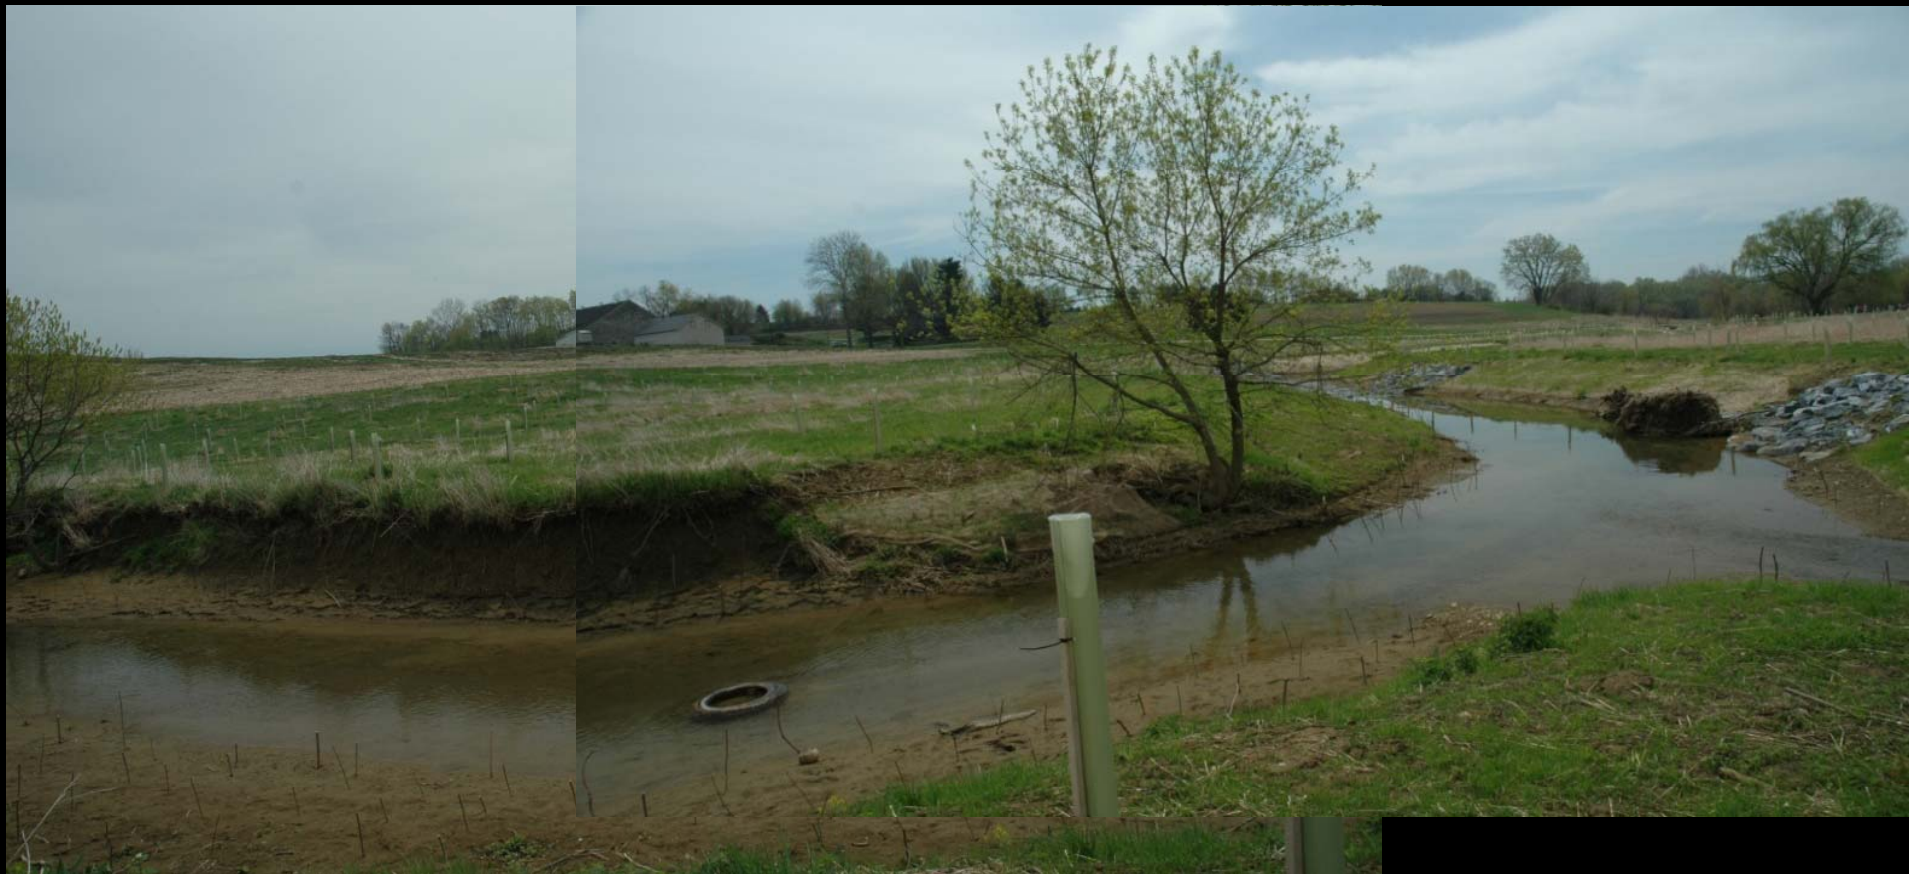
EXAMPLE 1: RECENT BREACH

Incision 6 months after dam removal, April 2009

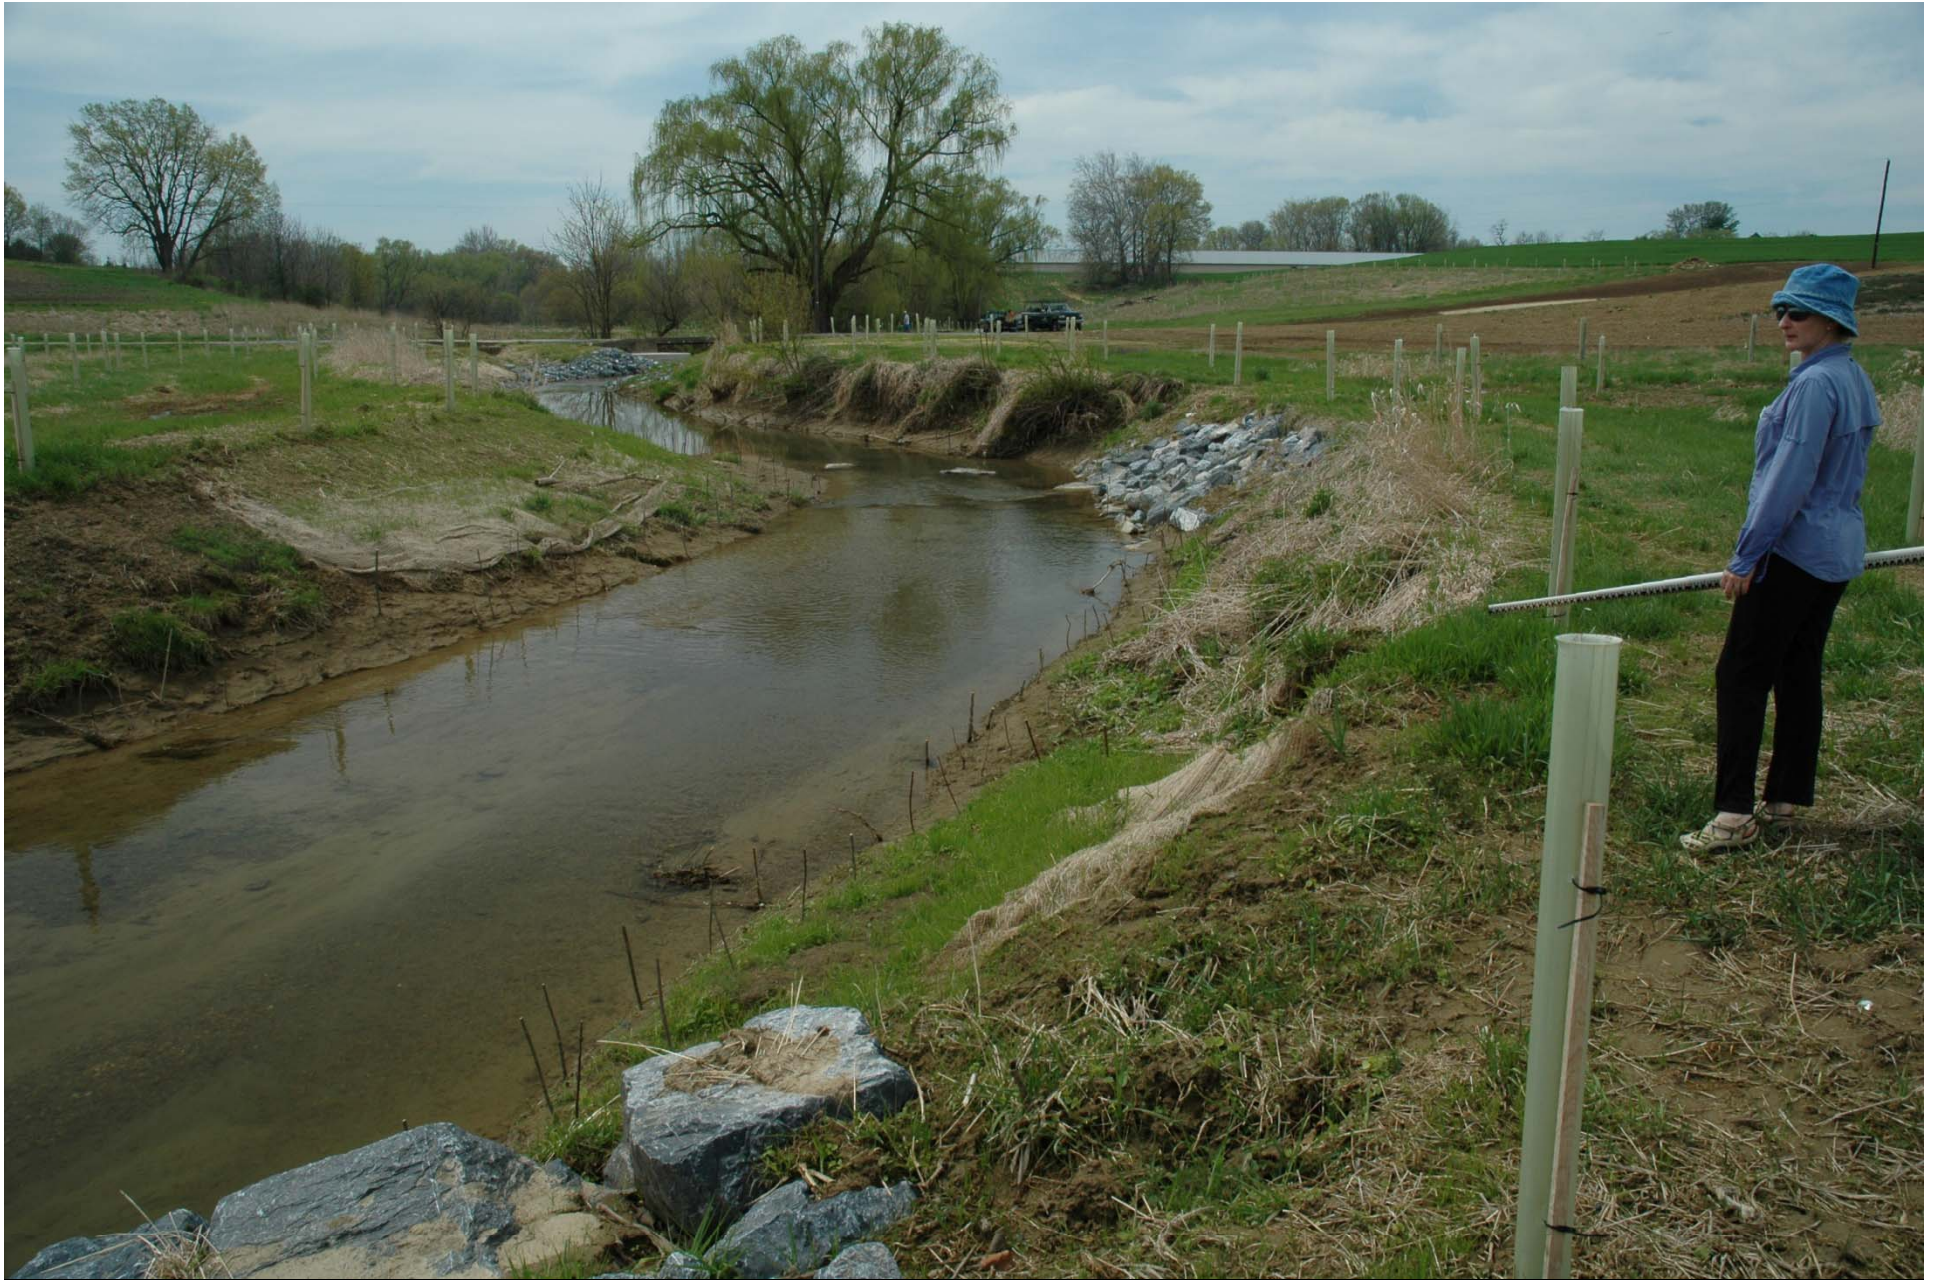
Boulders and tree planting 6 months after dam removal

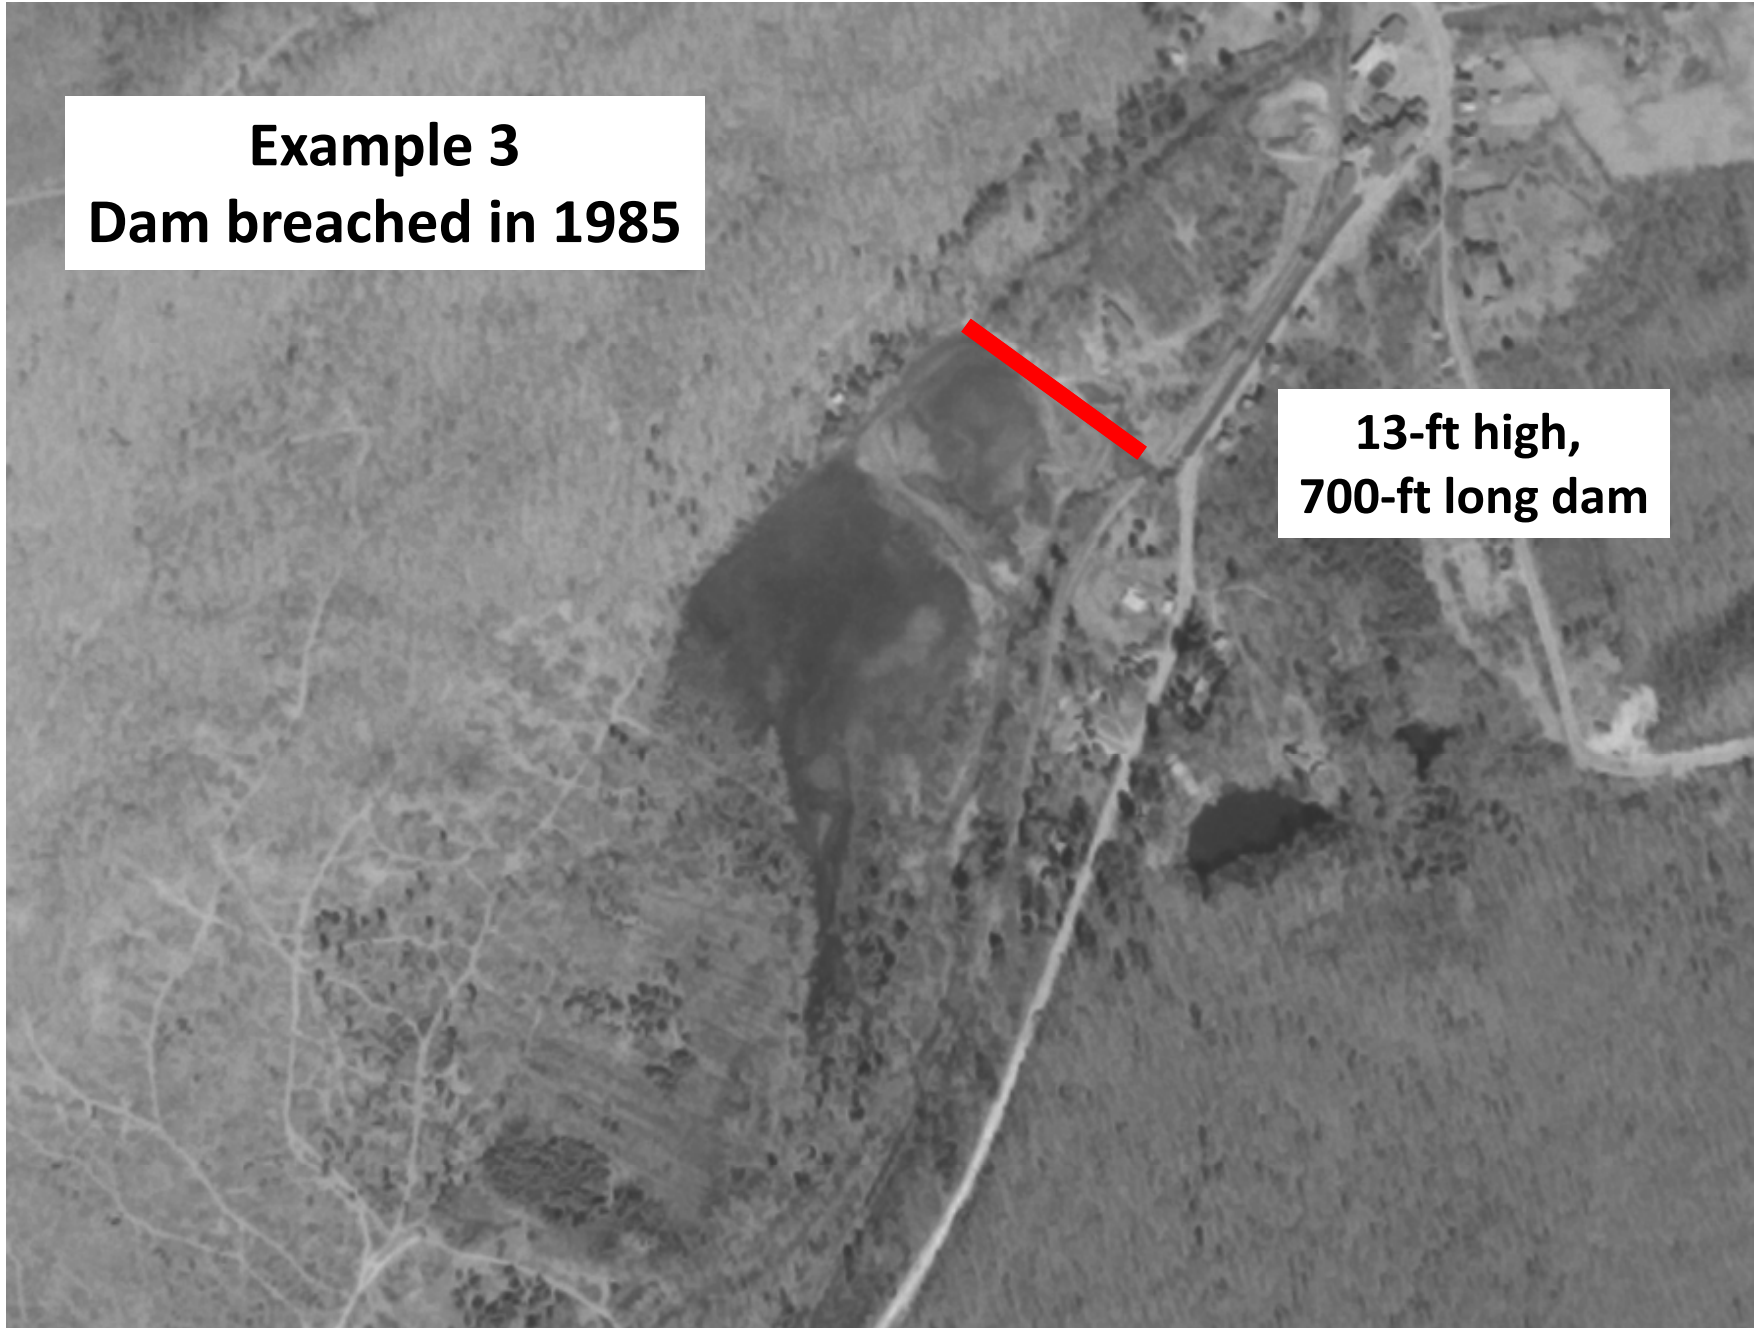
Mt Holly--Mountain Creek, Ridge and Valley, PA—1968 air photo

Example 3
Dam breached in 1985

**13-ft high,
700-ft long dam**

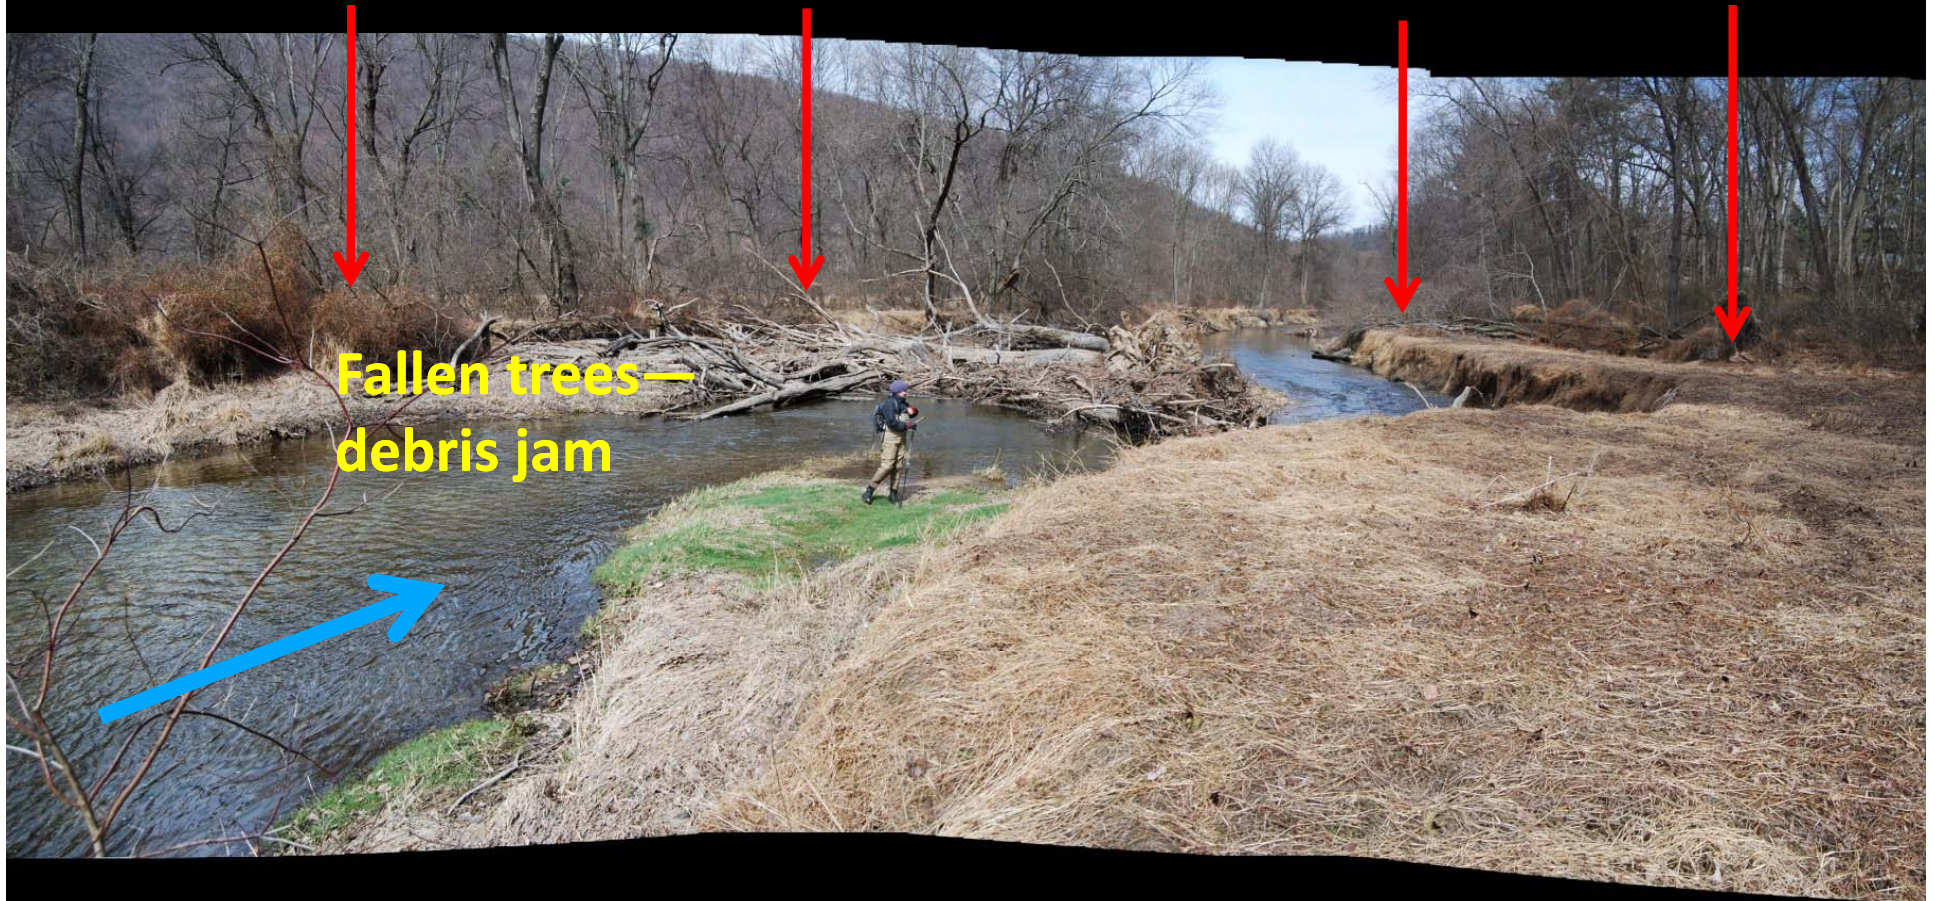
Incision, Channel Bank Erosion, Tree Collapse

ORIGINAL MILL POND SURFACE PRIOR TO 1985

**Channel Bank Erosion, Tree Collapse,
Debris Jams, and Accelerated Bank Erosion**

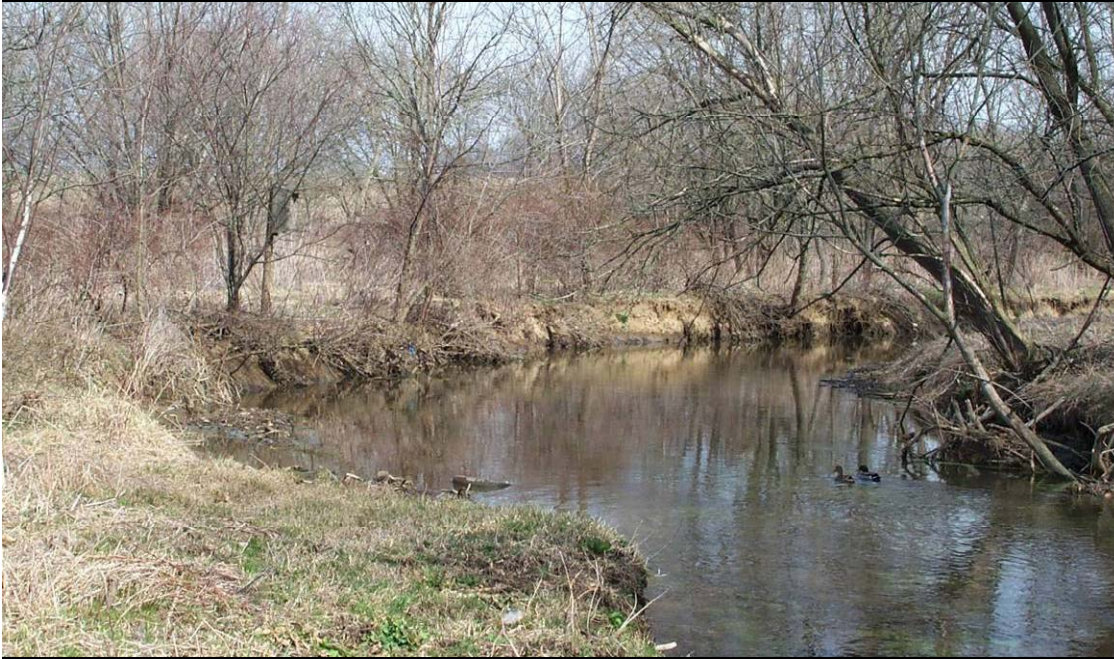
BEFORE, 2004, Impaired with legacy sediment

**Banta Mill
Floodplain/Wetland
Restoration, Lititz Creek, PA**

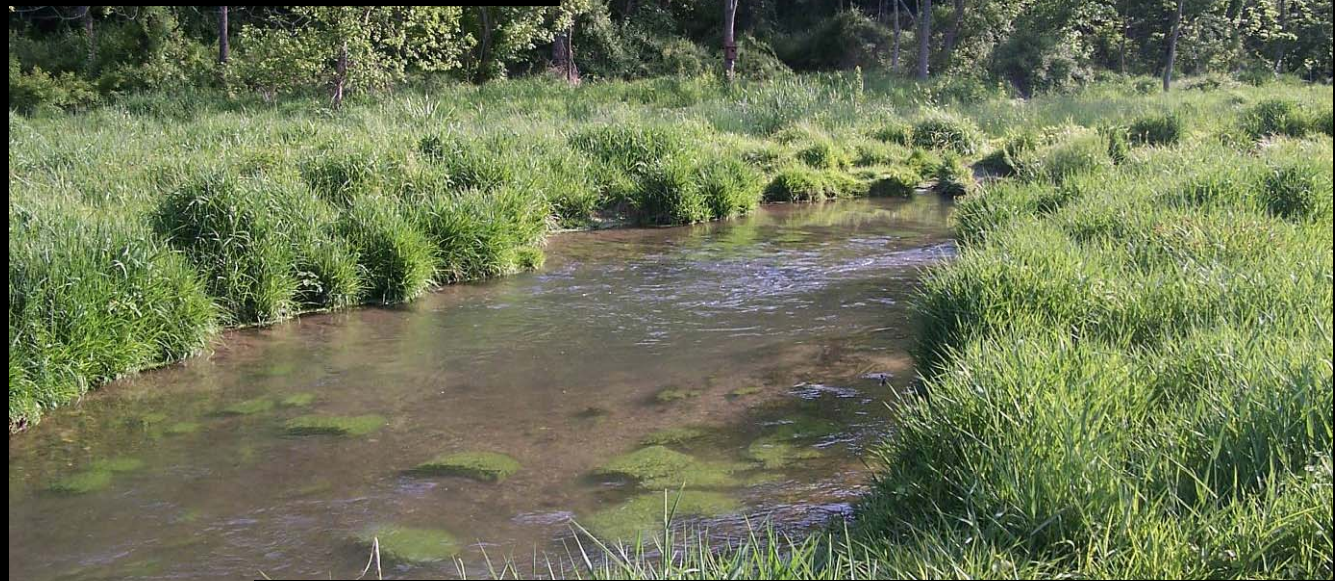
**Viable Holocene
wetlands—
contrast with
Watts Br approach
to restoration**

AFTER, 2007, Legacy sediment removed

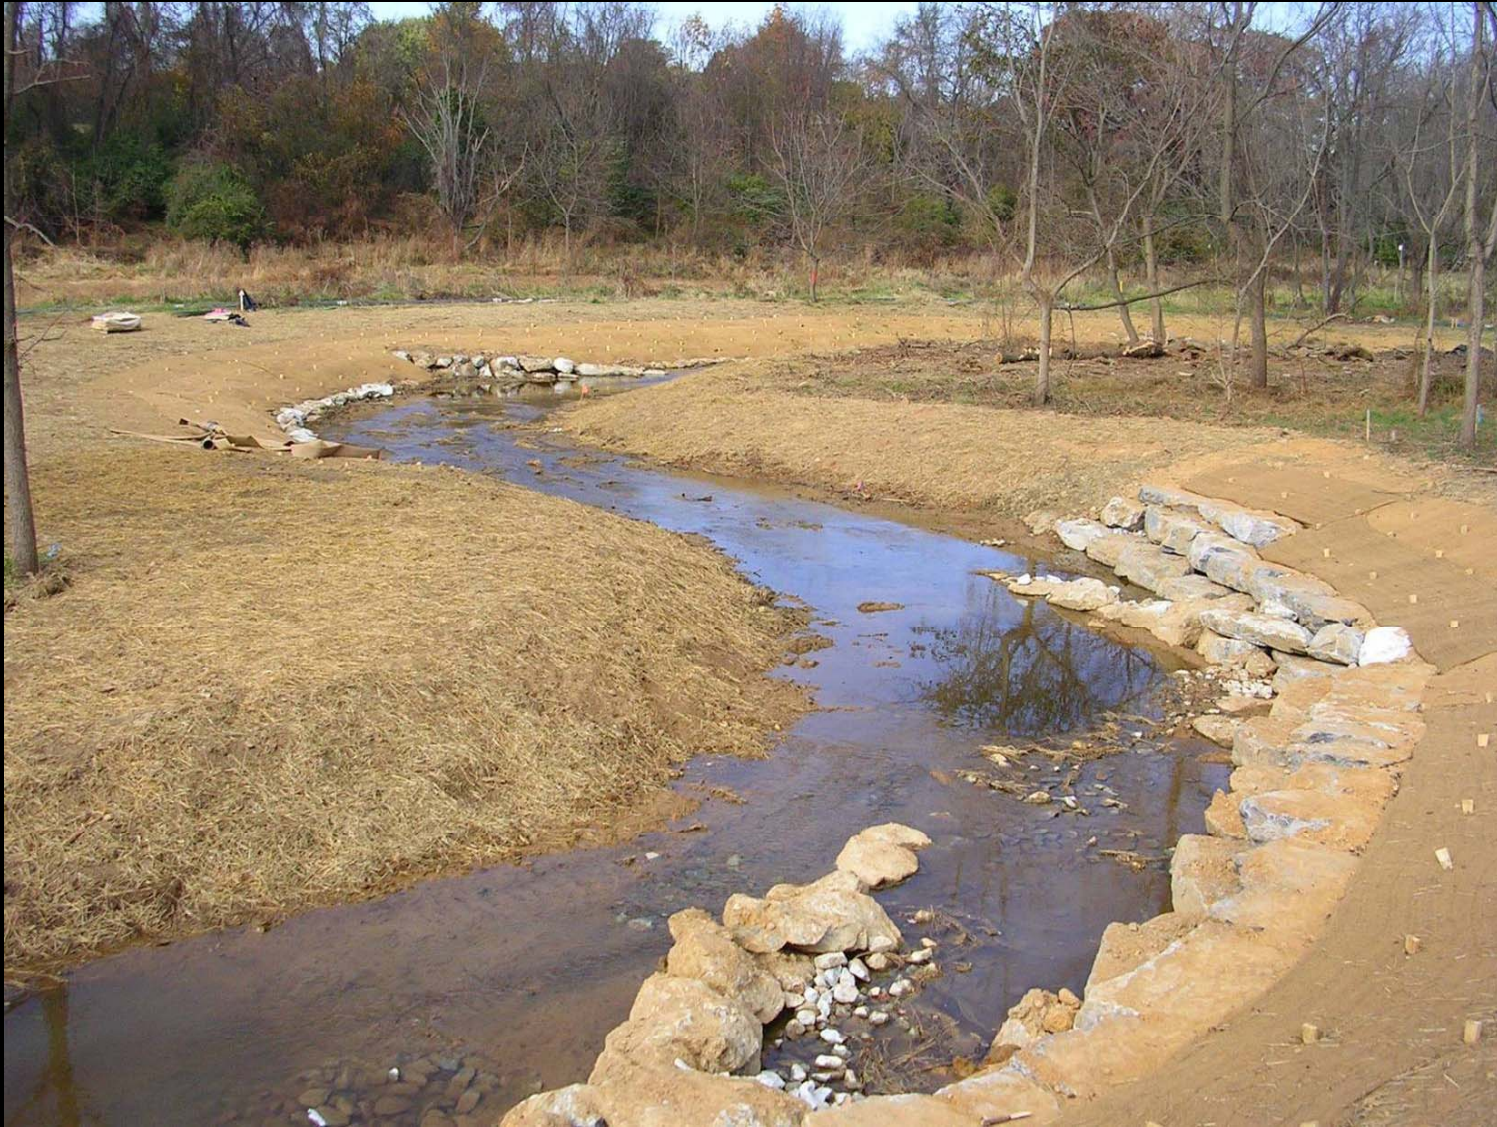
**Channel-centered view of stream restoration (2005) and
meandering streams, Watts Branch, MD (\$1.6 million)**
