Legacy Sediment

**What is it, Where is it,
How did it Get There, and
Why does it Matter?**

**Dr. Dorothy Merritts, Franklin and Marshall College
Dr. Robert Walter, Franklin and Marshall College**

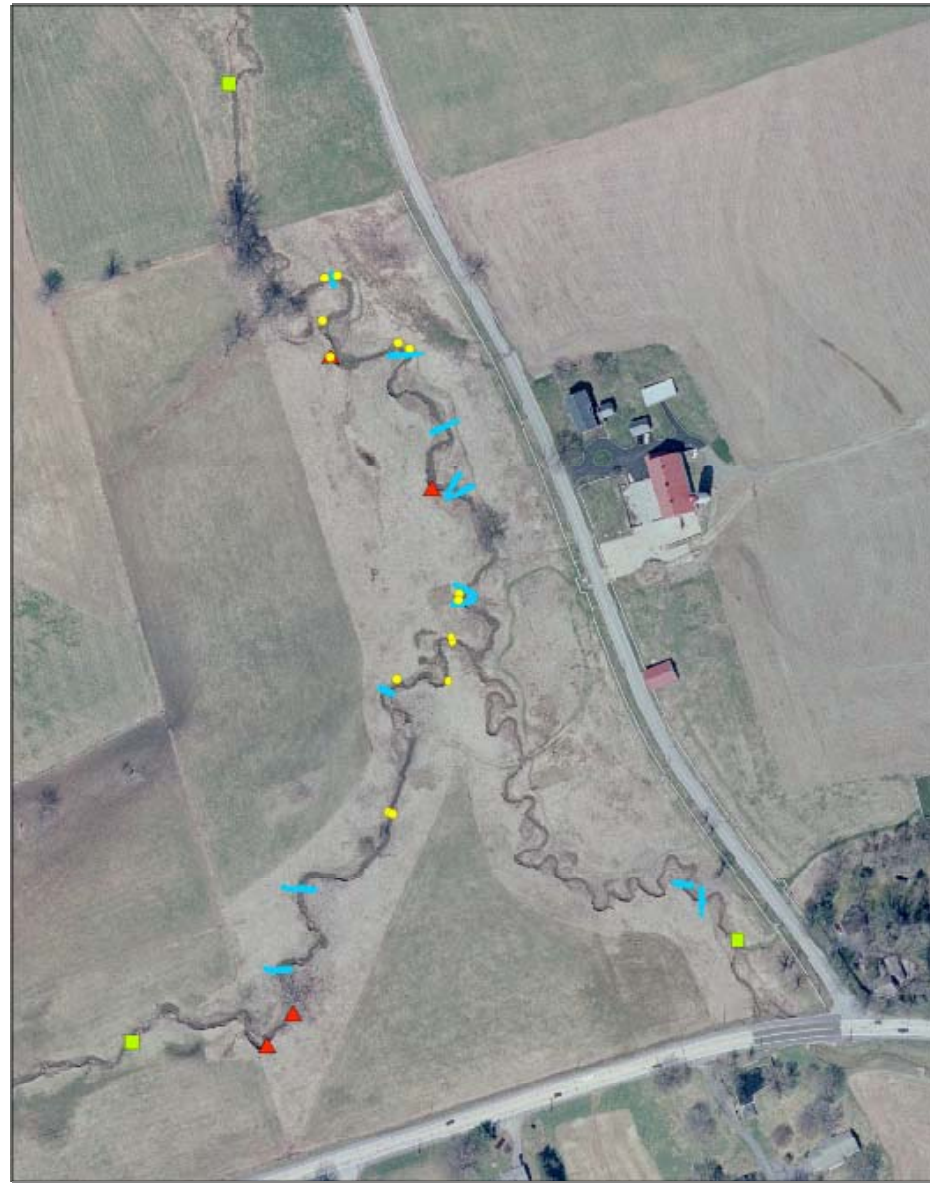
BIG SPRING RUN, LANCASTER COUNTY, PA, WETLAND-FLOODPLAIN RESTORATION EXPERIMENT

- USGS Gage Stations
- ▲ Seed Collector Sites
- Bank Erosion Pin Sites
- ▬ Stream Cross Sections
